Clock Tower

Location: Cooks Garden

Built Heritage Inventory

WHANGANUI
DISTRICT COUNCIL
Te Kaunihera a Rohe o Whanganui

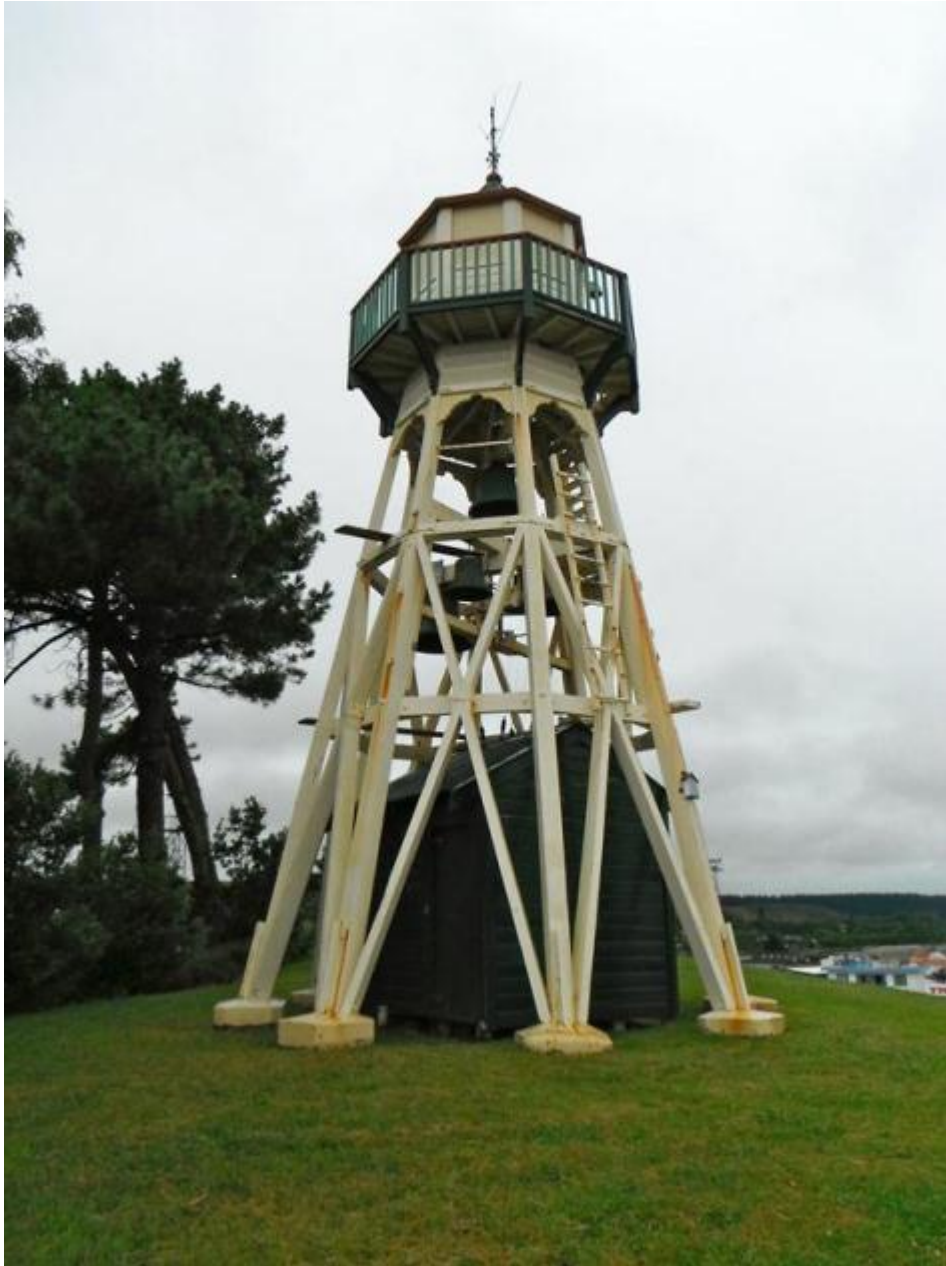
Physical Description: The timber framed, 6m high octagonal clock tower has played timber posts with cross bracing supporting bells at the first level and a tower with a surrounding walkway at the top. The tower has a concave curved roof with metal finial. The walkway is supported on simple angled timber

brackets and underneath it the posts are joined by curved brackets, possibly Classical in design.
