Built Heritage Inventory

Standard Chain Measure

Location: Market Place; Taupo Quay; Heritage NZ Pouhere Taonga Bates Street, Moutoa Gardens, List Number: 7101 Moutoa Gardens, Whanganui

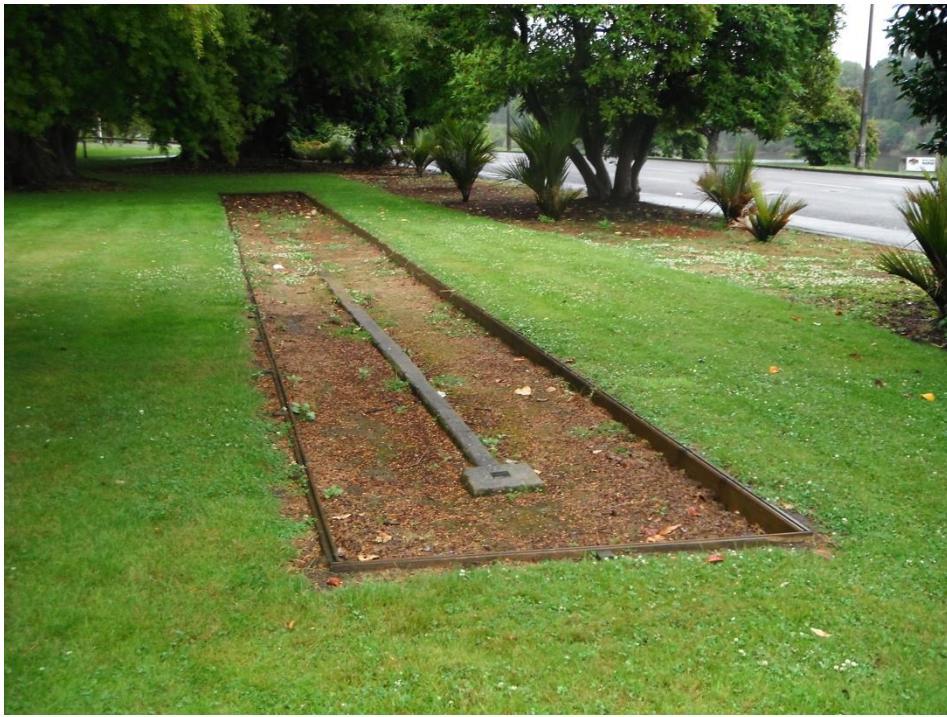
Physical Description: The Standard Chain Mark, originally called a monument, comprises a strip of concrete lain in the ground with square concrete blocks at either end into which brass plates are laid. The north brass plate has two projections into which one end of the chain was inserted and the other end comprises a plate with a line inscribed showing the exact dimension of one chain. The strip has impressed into the concrete "N.Z. SURVEYS CHAIN STANDARD 1880 66 FEET". The concrete has a variable thickness of cement render on top.

The Wanganui chain is set in a gravel bed with a timber frame.

Integrity: The chain mark has weeds growing in the gravel bed.
