## WHANGANUI DISTRICT HERITAGE INVENTORY

**Register Item No:** 320      **Type:** Building  
**Name:** WANGANUI AIRPORT TERMINAL and CONTROL TOWER

**Location:** Wanganui Airport

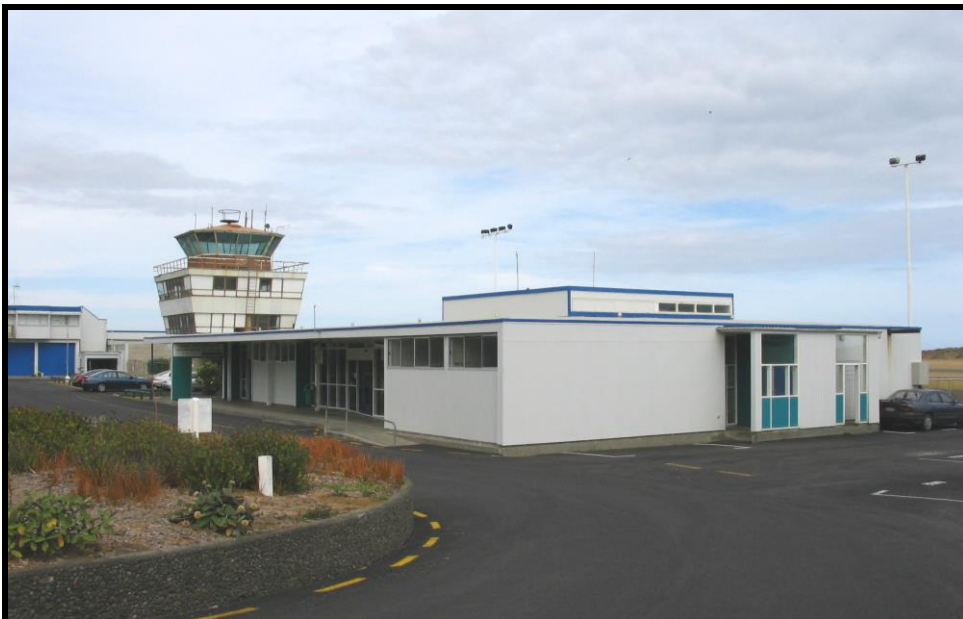
Wanganui Airport Terminal and Control Tower, opened in December 1961.

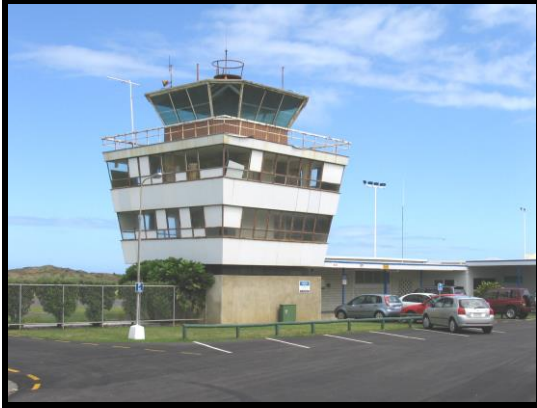
The terminal building is currently undergoing renovations, mainly to the interior. Externally it appears in good condition. The control tower is suffering badly from lack of maintenance and continual weathering in this exposed site. The steel frames to the windows are rusting badly and need to be replaced, preferably with aluminium which will be able to withstand the weather conditions. The flat roof below the cab also needs repairing as leaks are occurring.

The Control Tower, now in need of restoration. Some glass panes have already been removed.

The Control Tower should be restored so it can remain as an integral architectural feature of the terminal building. New uses for the Control Tower need to be determined with the input of the Control Tower Restoration Group, Wanganui District Council and the Airport Management Board. The Terminal and

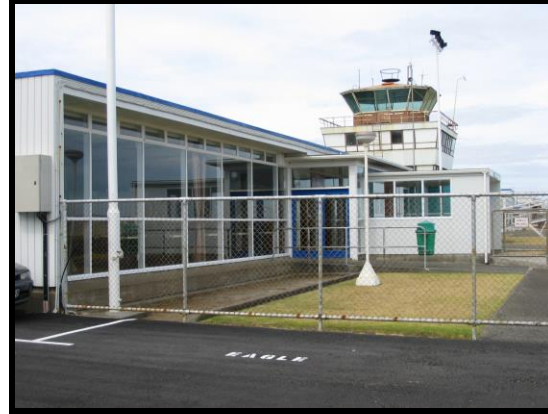
Alterations have been made to the terminal building: the roof-top viewing platform, accessed by an external stairway, was removed; an air-side atrium was added to provide shelter for passengers prior to embarkation and on arrival; part of the front wall has been altered in the vicinity of the public toilets. The control tower, however, has had no alterations since it was built. Many panes of glass have been removed recently for safety reasons.

The terminal and control tower viewed from air-side. Note the atrium for passengers, an addition to the original building, which once had a viewing platform on the roof.
